BMW - ñõàìù Mitchell On-Demand.

WIRING DIAGRAMS

1988 BMW 325i

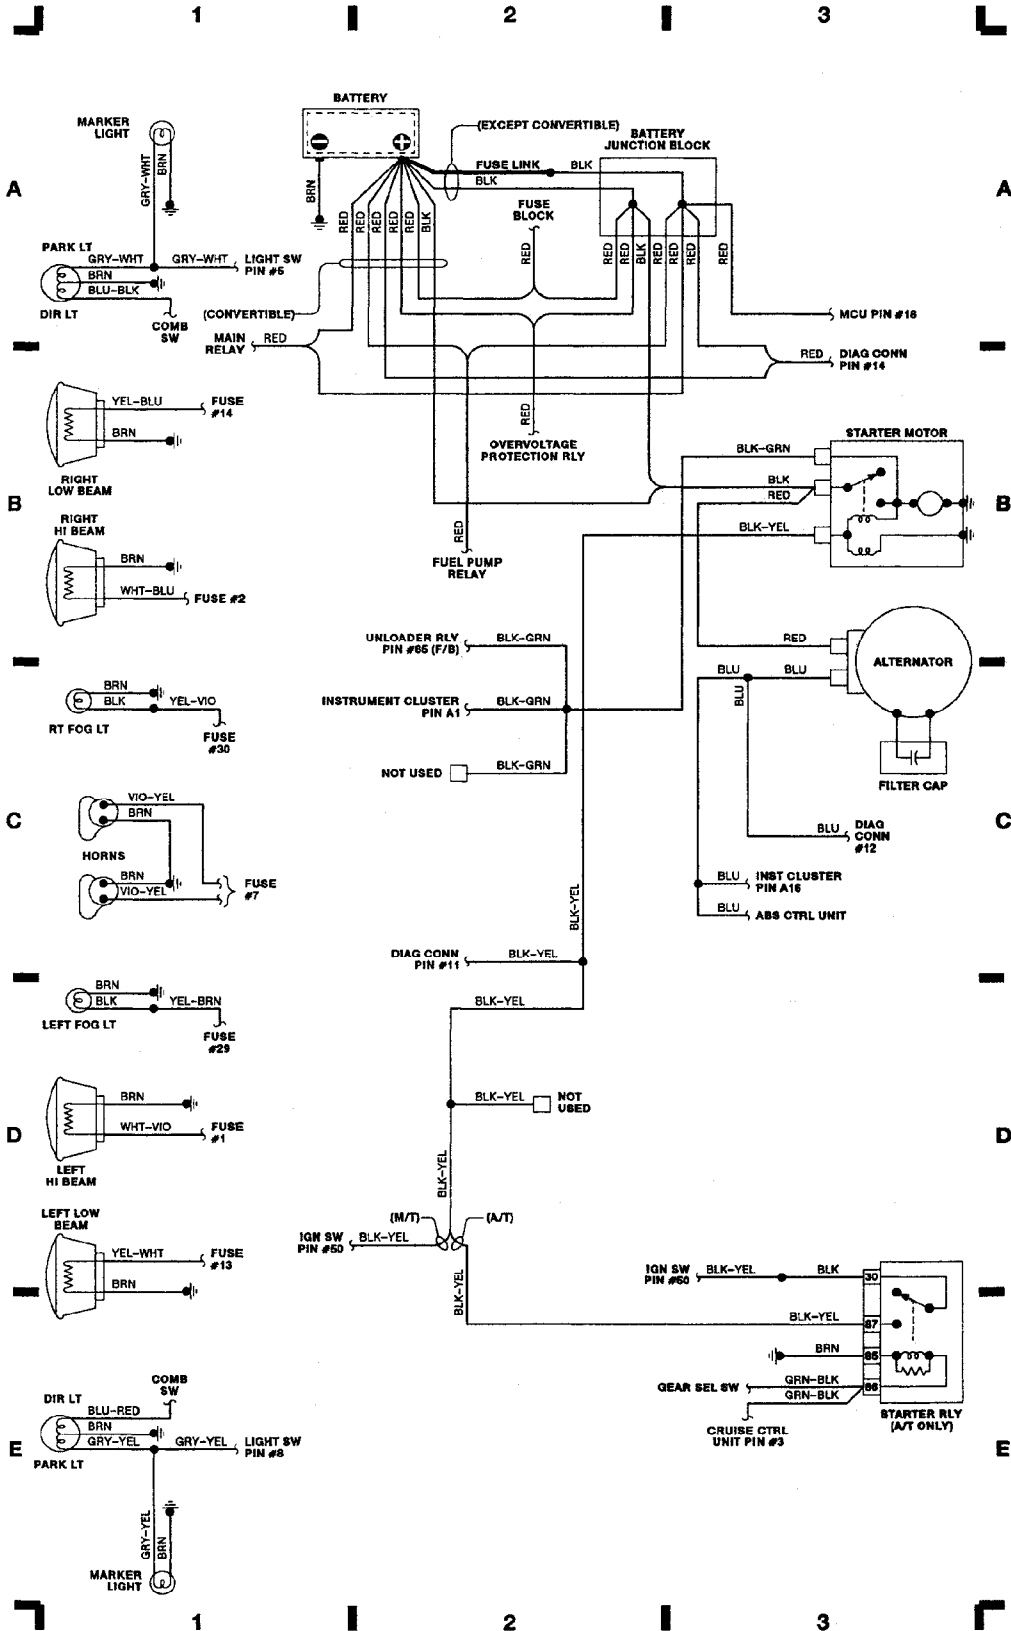
Fig. 1: Engine Compartment

COMPONENT LOCATOR:

A/C CONTROL SWS	C 16
ABS CONTROL UNIT	A-B 20
ACTIVE CHECK CONTROL UNIT	E 20-23
ALTERNATOR	B-C 3
AUTO CHARGE FLASHLT	F 36
AUX FAN BLOWER RESISTOR	C 12
AUX FUSE BLOCK	D 12
BACK-UP LT SW	D 36
BATTERY	A 2
BATTERY J/B	A 2
BRAKE FLUID LEVEL SW	C 31
BRAKE SW	D 20
CENTRAL LOCK CTRL UNIT	A-B 39
CHIME MODULE	C 19
CIG LIGHTER	D 32
CLUTCH SW	C 26
COMBINATION SW	C 24
COMPUTER HORN	E 17
COMPUTER MODULE	E 19
CRUISE CTRL SW	E 27
CRUISE CTRL UNIT	D 27
DEFOG CTRL	F 40
DIAG CONN	E 5-6
DOME LT (CONVERTIBLE)	B 40
DRIVERS DOOR JAMB SW	B 41
DUAL TEMP SW	C 15
FOG LT SW	C 24
FUEL PUMP	A 7
FUEL PUMP RLY	B 7
FUSE BLOCK (PARTIAL)	B-D 8-11
FUSE BLOCK (PARTIAL)	A-B 12-15
GEAR SEL SW (A/T)	C 35
HAZARD SW	D-E 24
HIGH LEVEL STOP LT ASSY	C 43
HORN SWS	D 33
IGNITION COIL	A 4
IGNITION KEY-IN SW	C 18
IGNITION SW	E 12-15
INSTRUMENT CLUSTER	A 26
INTERIOR LT TIME CTRL	A 40
K10 WIPER CTRL UNIT	E 32
LEFT FUEL TANK SENDER	C 41
LEFT/RIGHT DOME LTS	A 42
LIGHT SW	A-B 24
MAIN RLY	D 7

MAP READING LT	C 20
MIRROR CTRL SW	C 32
MULTI-FUNCTION CLOCK	D 16
ON BOARD COMPUTER RLY BOX	D 17
OVERVOLTAGE PROTECT RLY	C 23
OXYGEN SENSOR	B 7
POWER ANTENNA	D 36
POWER WINDOW CB (CONVERTIBLE)	B 33
POWER WINDOW CB (W/O CONV)	A 37
REAR LTS CHECK RLY	A 27
REAR WINDOW BLOWER RLY	D 42
SEAT BELT WARN TIMER	E 17
STARTER MOTOR	B 3
STARTER RLY	E 3
SUNROOF SW	D 40
TRUNK LT SW	C 42
WASHER PUMP	E 33
